ASH POND D DESIGN & CONSTRUCTION HISTORY POSSUM POINT POWER STATION DUMFRIES, VIRGINIA

Introduction

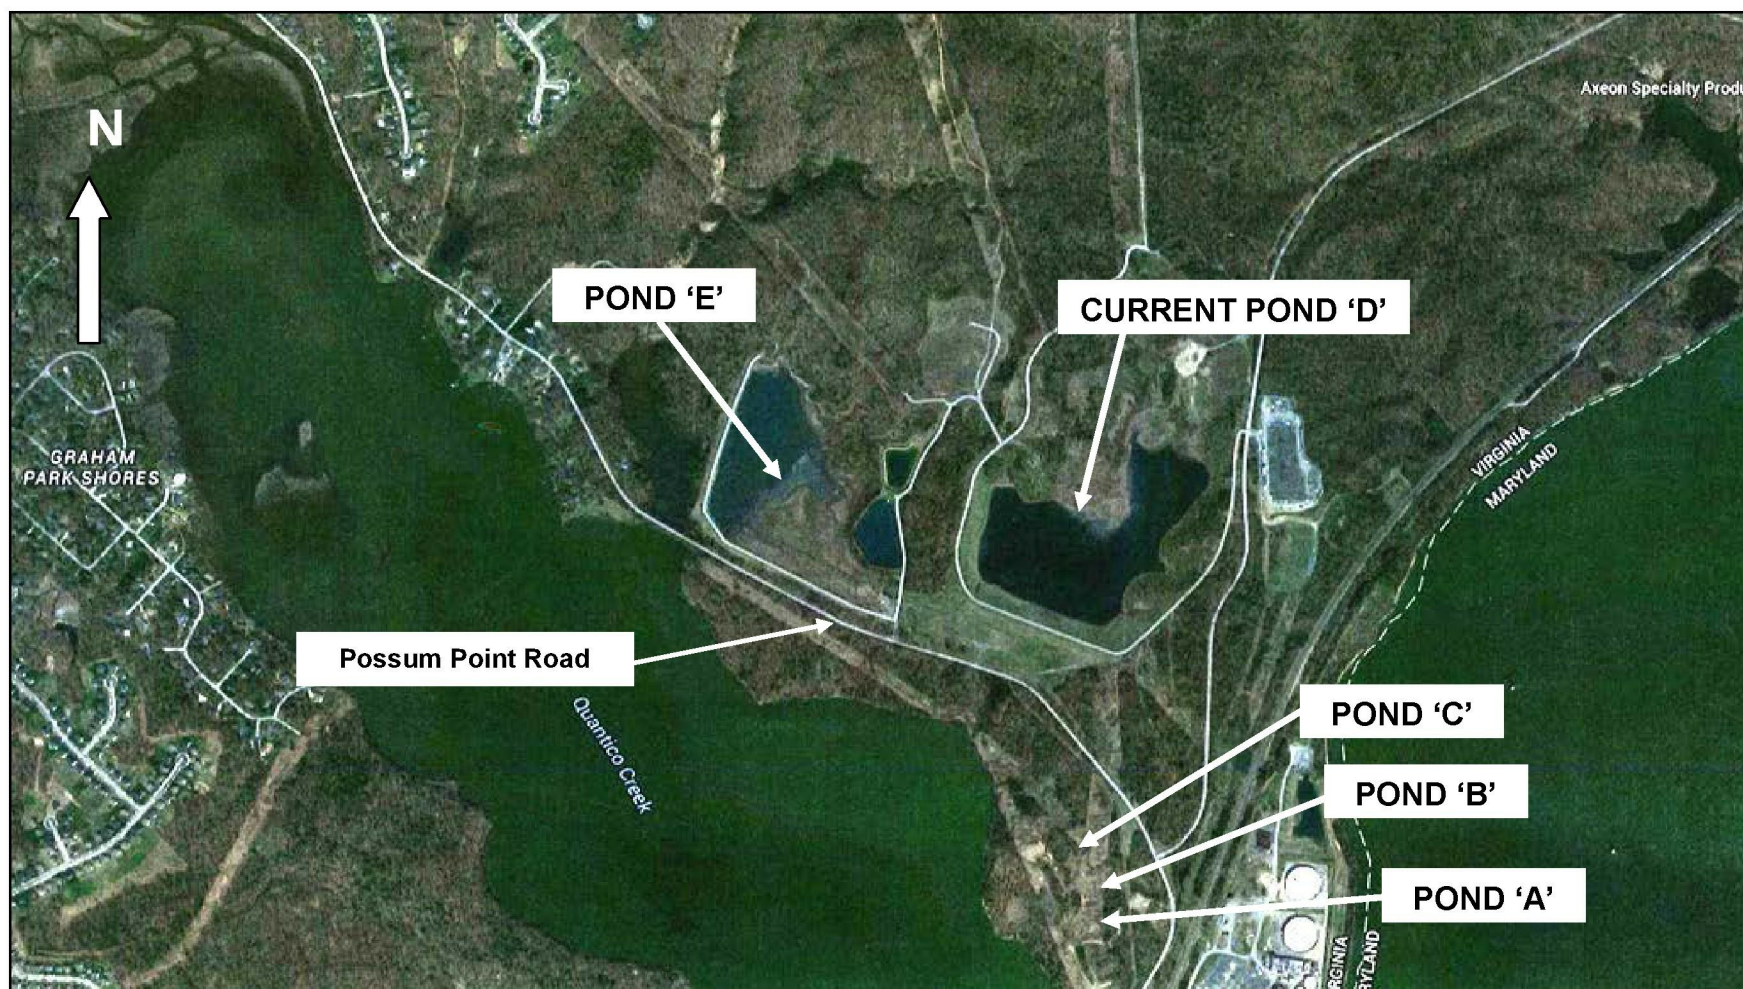
FIGURE 1
POSSUM POINT ASH PONDS - AERIAL VIEW

As noted above, there are five ash ponds at Possum Point that were constructed at various times within the history of the Station to store coal combustion residuals (fly ash and bottom ash) from power generating operations. These are shown on Figure 1. Ponds A, B, and C are located west of Possum Point Road and were used to store sluiced ash until the early 1960's. These were formed by damming three adjacent drainage ways and sluicing the ash to the formed impoundments. These filled by the early 1960's and original Ash Pond D was constructed on the north side of Possum Point Road by damming another natural drainage way. Its dam axis ran northwest-southeast and the dam had a crest elevation of +55 msl. Ash was sluiced to this location until 1967 when it filled to capacity. In 1967, Ash Pond E was constructed to the west of original Ash Pond D and was used to store day to day ash produced at the station until the Station stopped burning coal in 2004. Ash pond E was formed by damming another large natural drainage way to the north and west of the others. Figure 2 is the 1967 design drawing for Ash Pond E which shows the then existing Ash Pond D dam and the proposed Ash Pond E dam. Photo 1 shows the downstream slope of the old Ash Pond D embankment viewed from Possum Point Road.

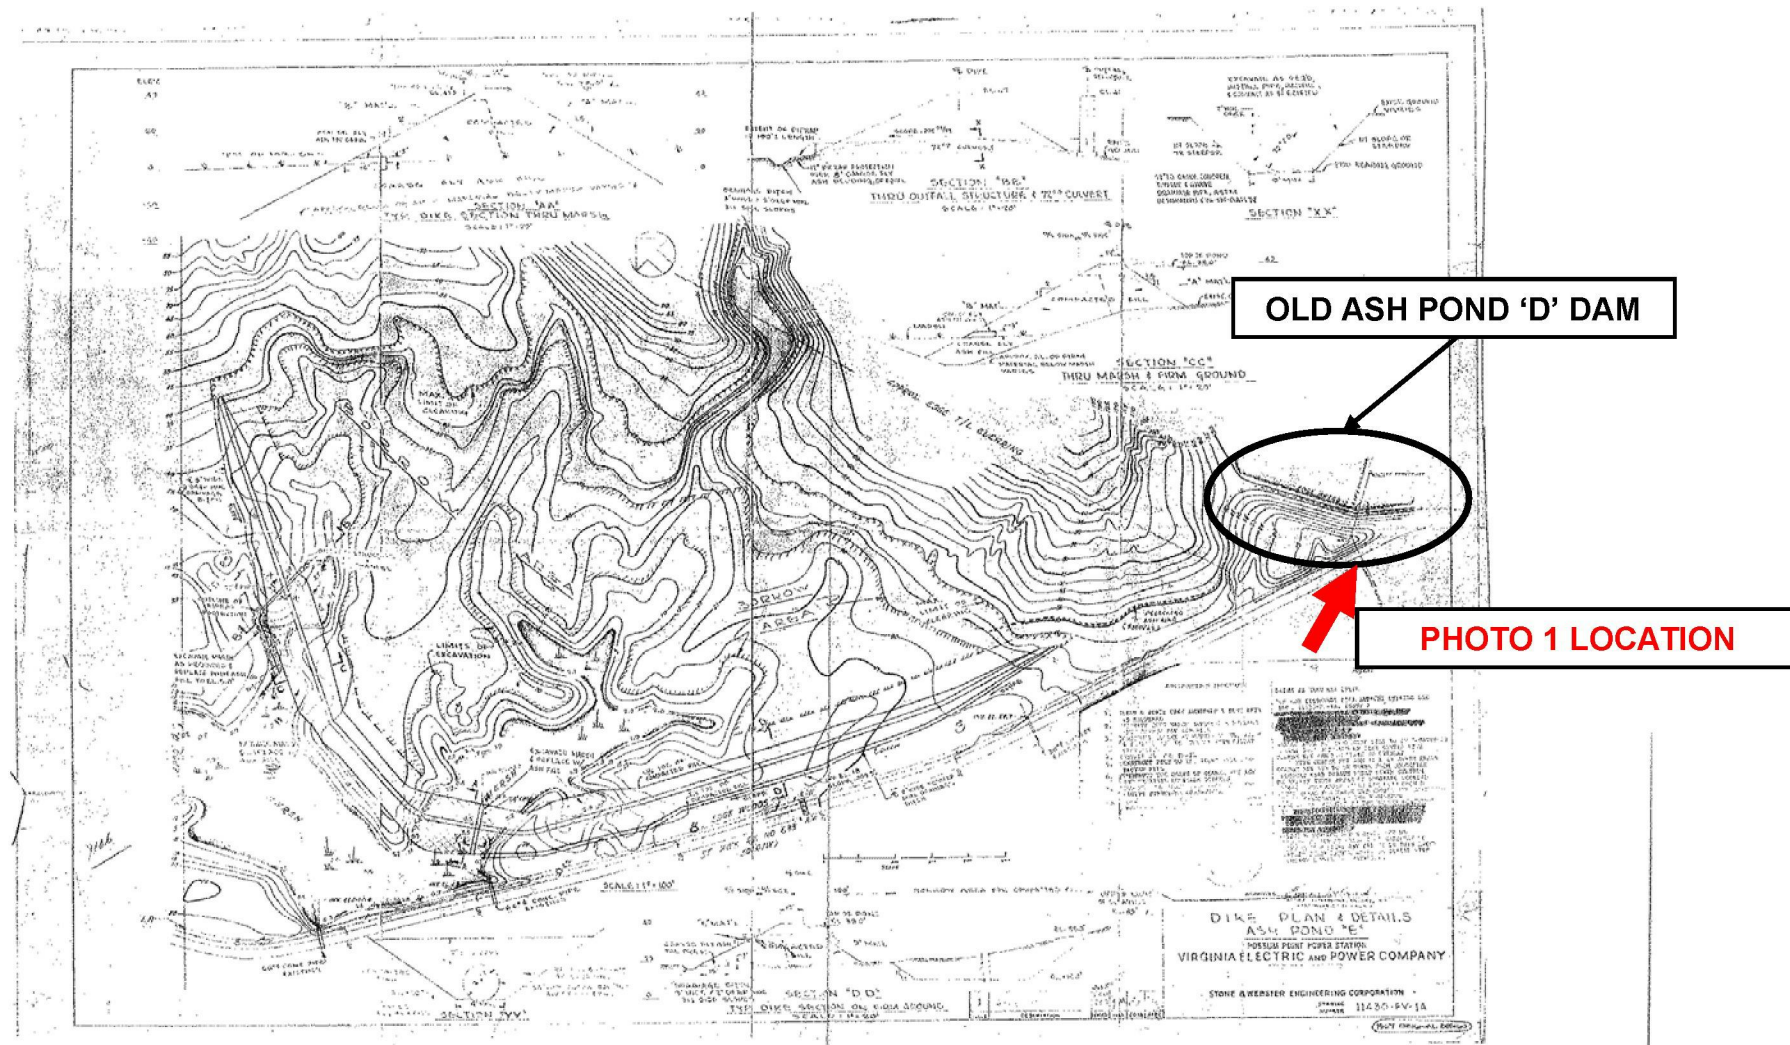
FIGURE 2
1967 ASH POND 'E' DESIGN DRAWING 11430-FY-1A
SHOWING THEN EXISTING OLD ASH POND 'D' DAM

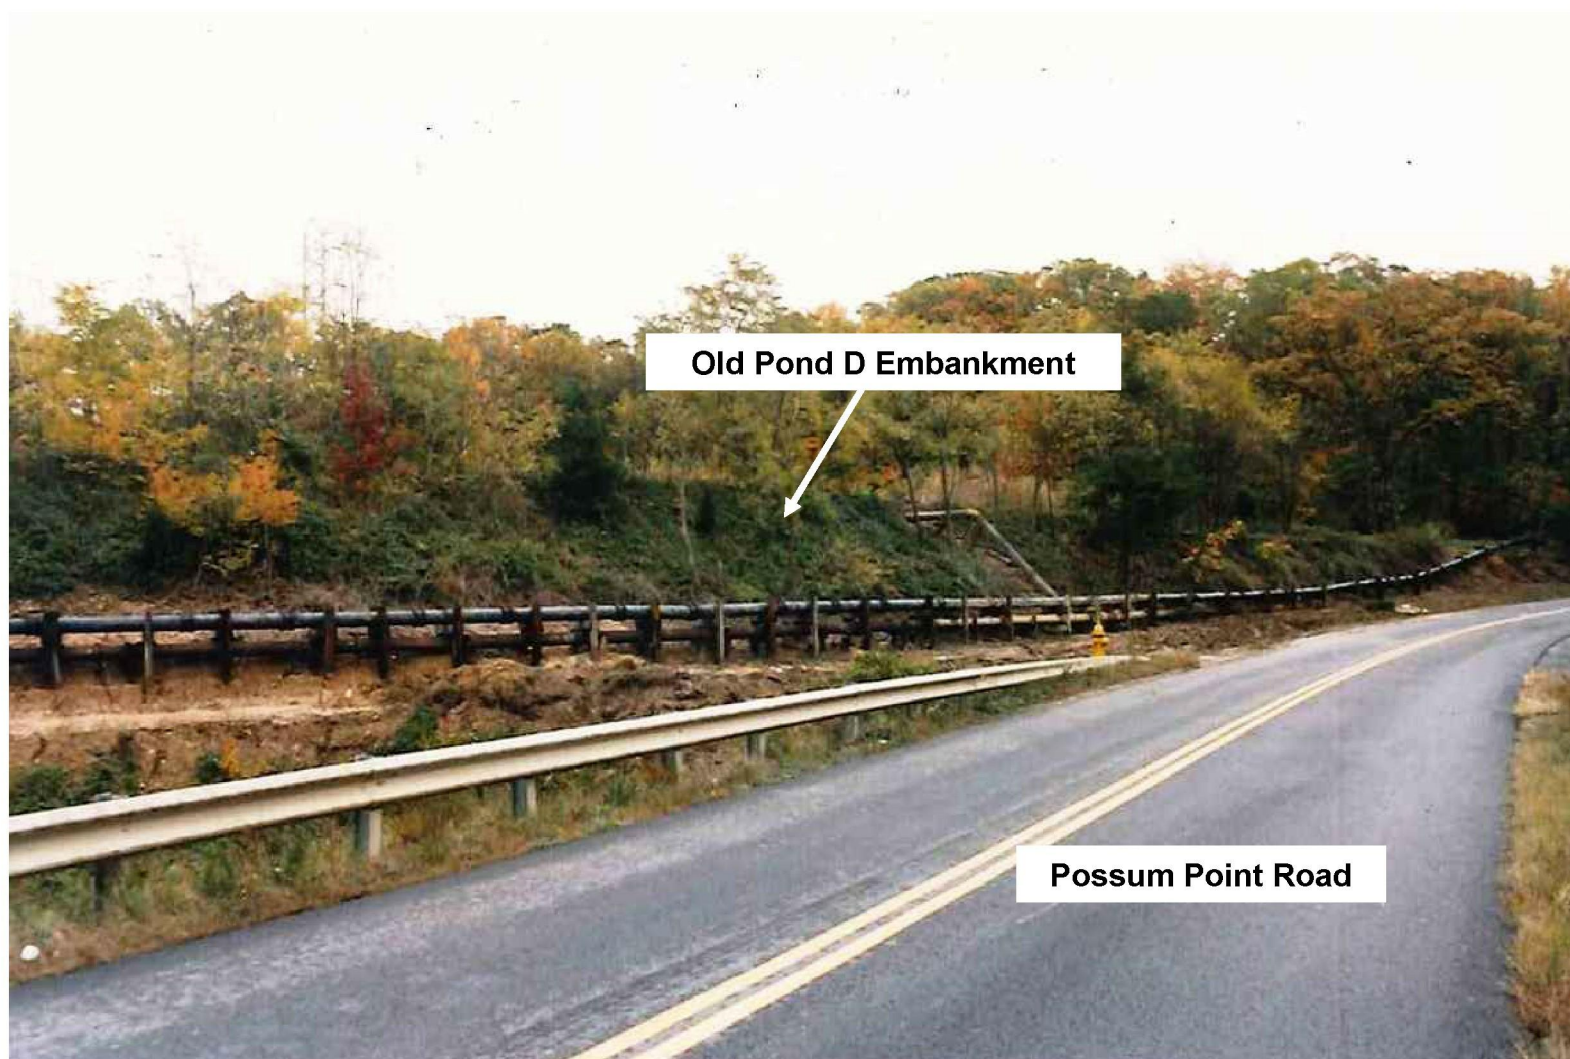
PHOTO 1
OLD POND D EMBANKMENT DOWNSTREAM SLOPE – 1986
CREST ELEVATION 55 +/-

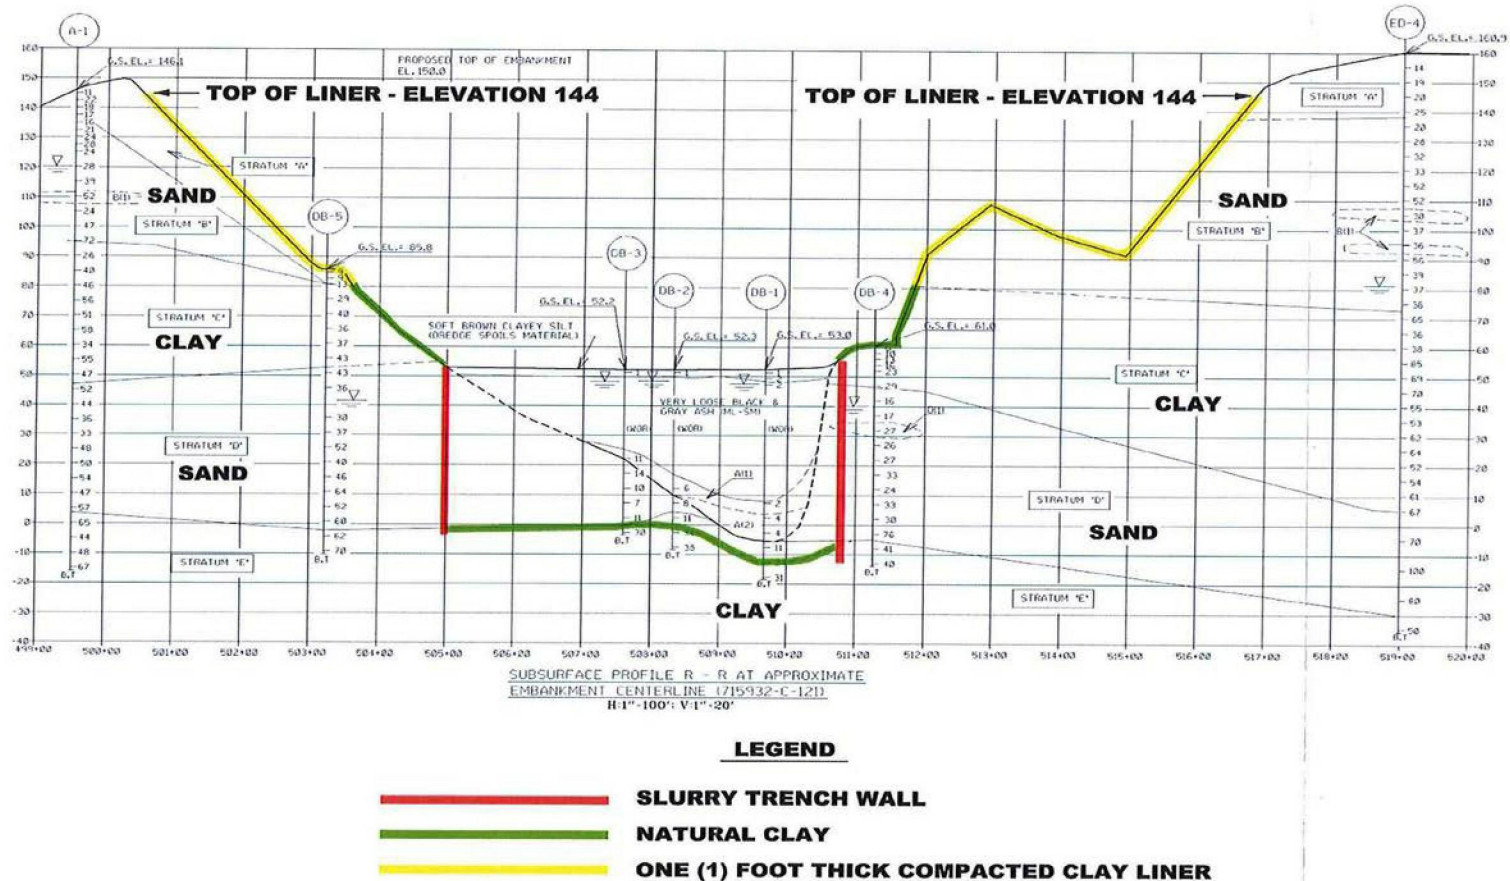
1988 GROUND WATER PROTECTION CONCEPT POSSUM POINT ASH POND 'D'

**FIGURE 3
SUBSURFACE PROFILE ACROSS PROPOSED
NEW ASH POND D DAM CENTERLINE**

The ash remaining from elevation 55+/- msl down to elevation 0 to +10 msl upstream of the new dam would be “surrounded” by a low permeability slurry trench wall. The wall would be keyed into a natural clay layer located below the entire site. From the top of the wall up to the Emergency Spillway elevation of +144 msl, the impoundment slopes would be lined with a minimum of one foot of compacted low permeability clay where the slope soils consisted of sand. Where the slope soils consisted of naturally occurring low permeability clay, no liner would be placed. Where there was a liner, it would be tied into the natural clay at their interface. This system would provide a continuous low permeability protective barrier to minimize any potential affects to groundwater from the ponded ash. Figure 4 shows the design location of the proposed new Ash Pond D dam, the old dam, the design location of the proposed slurry wall, and the proposed limits of the clay liner in a plan view. Figure 3 also shows the groundwater protection plan features in cross section.

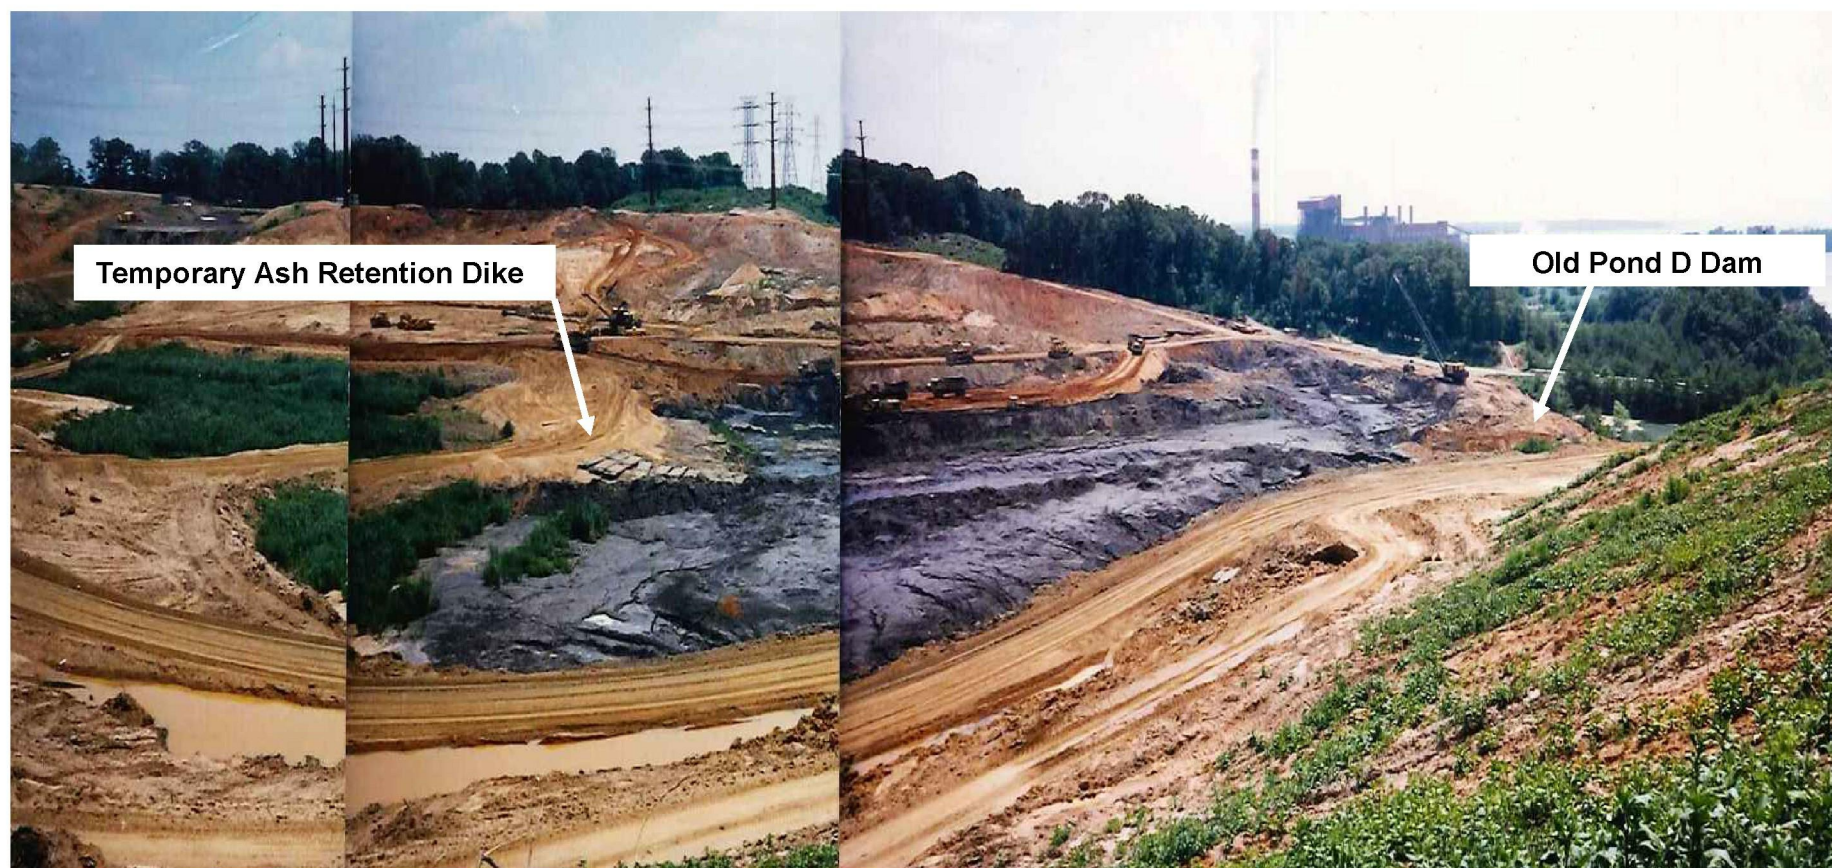
PHOTO 2
OLD POND D ASH WITHIN THE NEW DAM FOOTPRINT – SUMMER 1987

A part of the “new” Ash Pond D design effort in 1986, subsurface investigations were performed to identify subsurface conditions at the location of the proposed new dam and in areas that were being considered to obtain borrow soils for new dam construction. The new dam would be constructed where the old dam had previously impounded up to 50 feet of fly ash and bottom ash. In addition, there were up to 20 feet of soft sediments below the ash. In order to construct the new dam, it would be necessary to remove the impounded ash and soft sediments beneath the “foundation” of the new dam to provide a stable surface upon which to place dam fill and to limit settlement of the new dam. Figure 3 is a cross section developed from the subsurface investigations at the centerline of the proposed new Ash Pond D dam showing the ponded ash from the old dam, soft sediments below, and the naturally occurring soil layers along the abutments of the new dam (and within the proposed impoundment). Photos 2, 3 and 4 show the removal of ash from the old Ash Pond D within the footprint of the new Ash Pond D dam and initial placement of new dam fill.

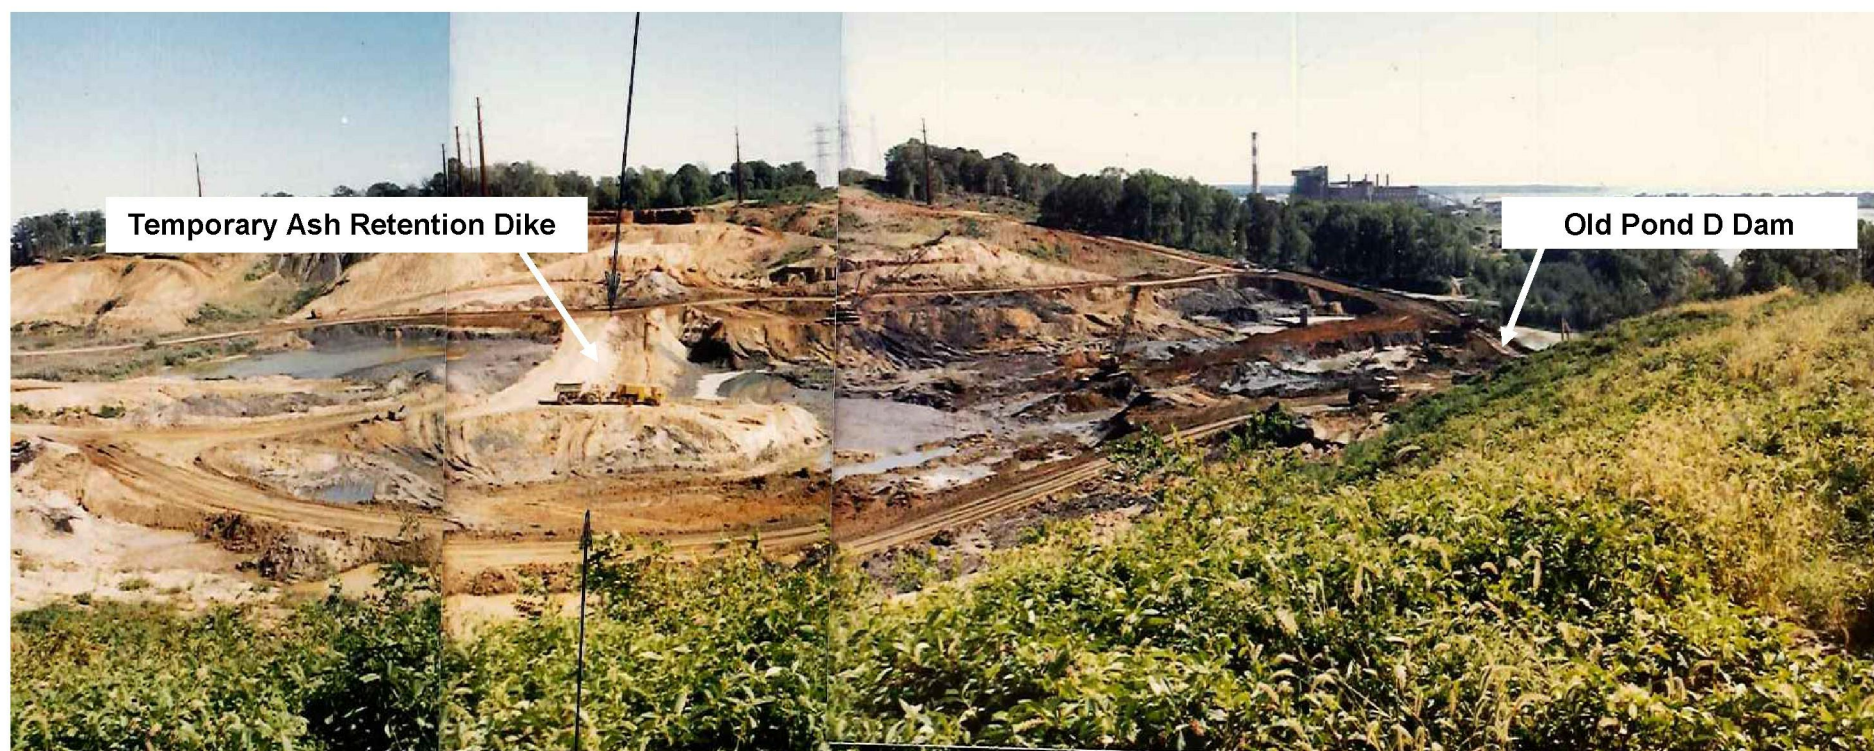
PHOTO 3
REMOVAL OF ASH FROM NEW POND D FOOTPRINT – OCTOBER 1987

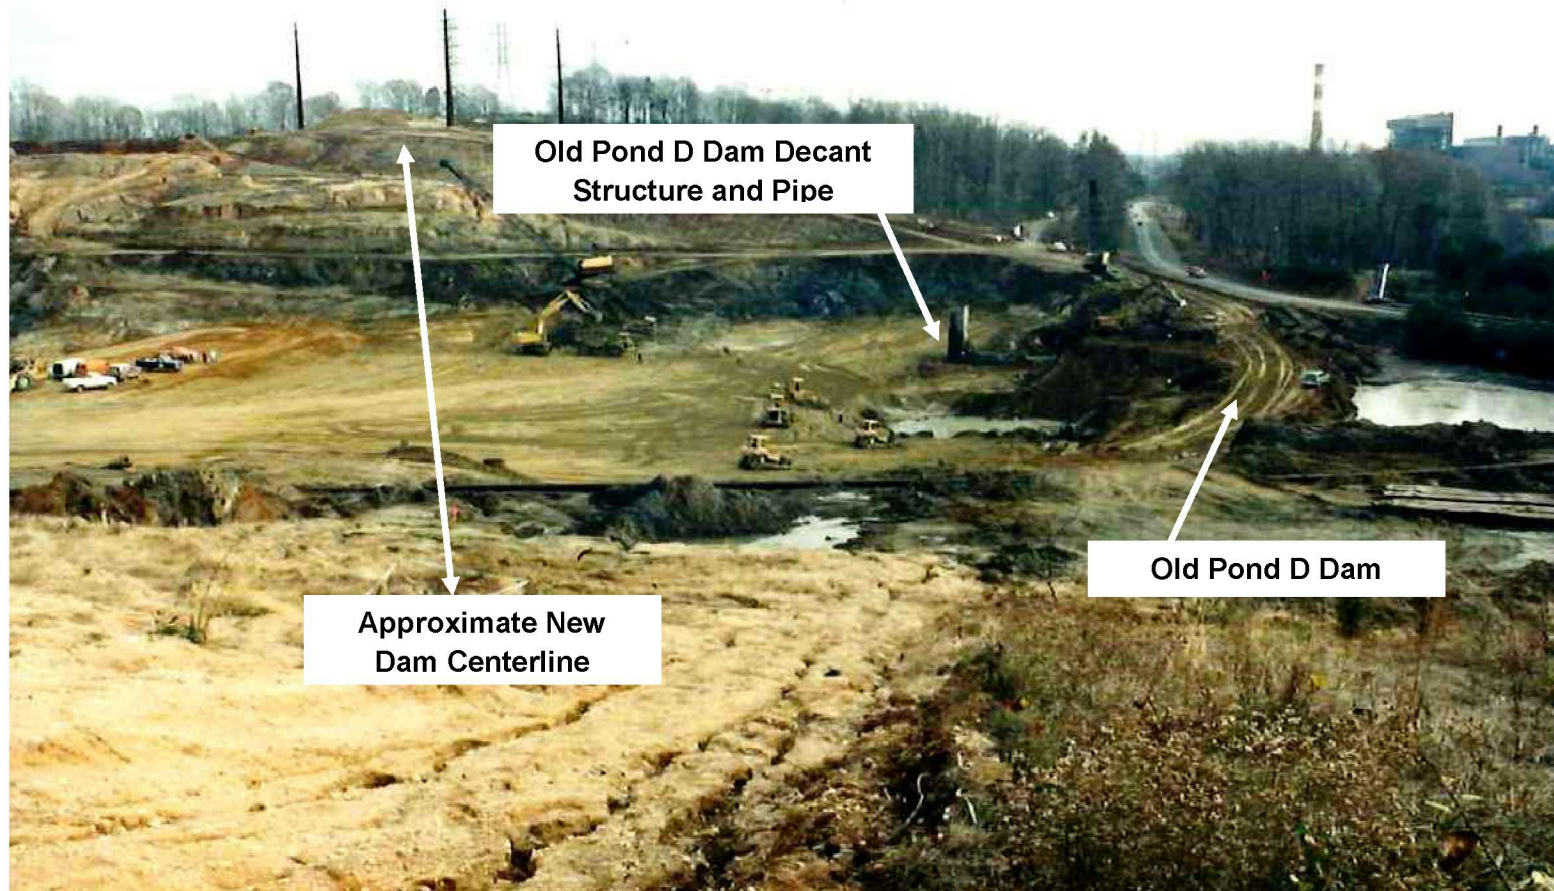
PHOTO 4
FILL OPERATIONS AT BASE OF NEW DAM – DECEMBER 1987
OLD ASH POND D DECANT STRUCTURE AND PIPE UNEARTHED

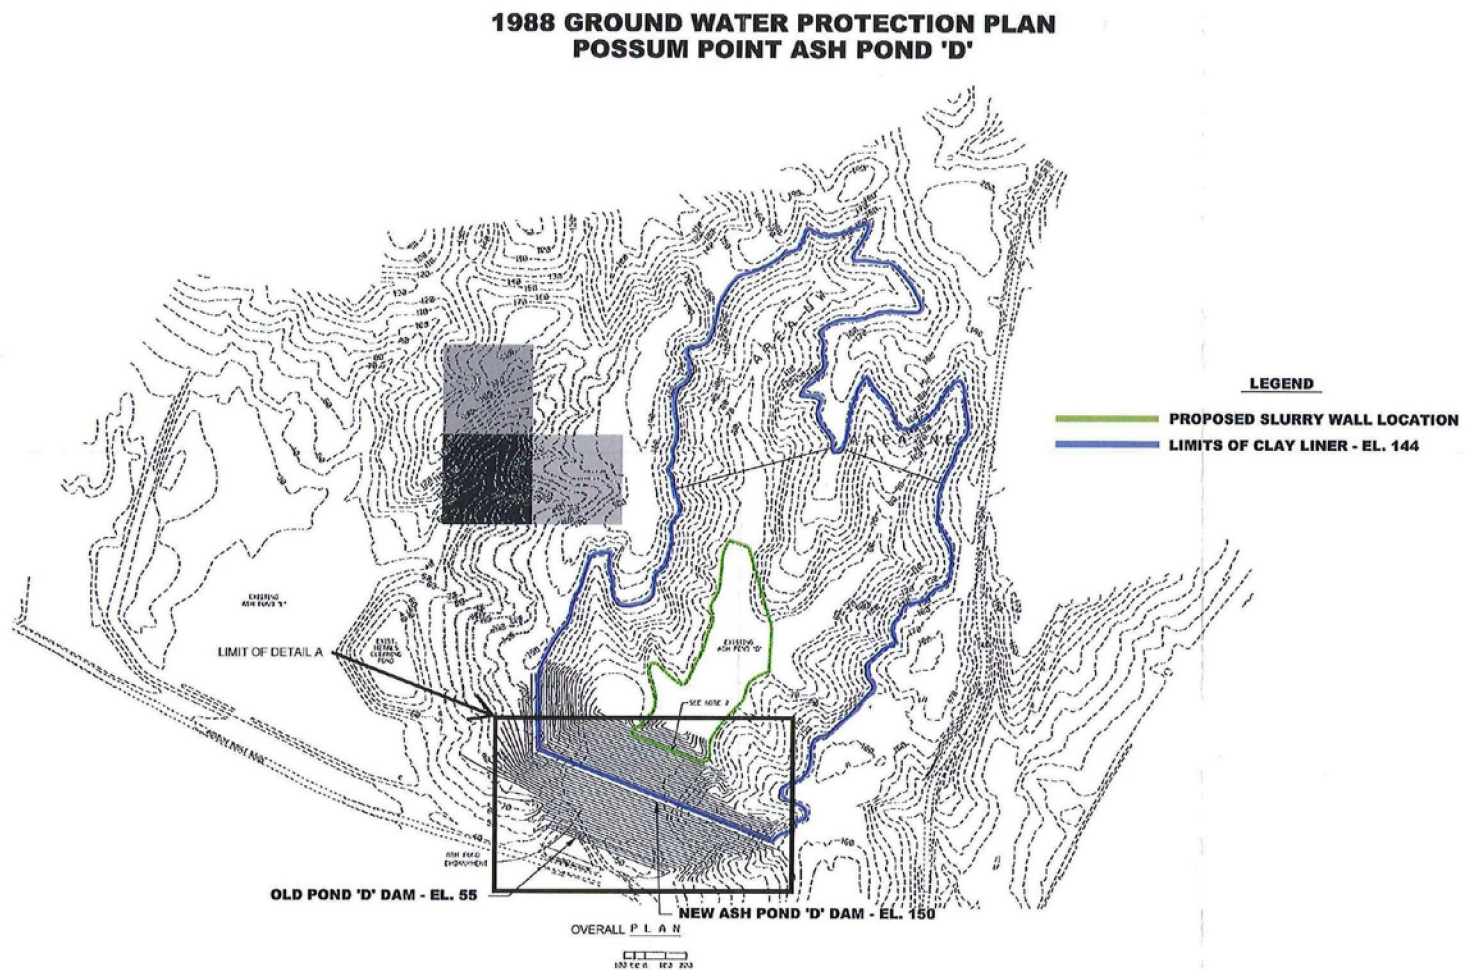
**FIGURE 4
NEW ASH POND D GROUNDWATER PROTECTION PLAN**

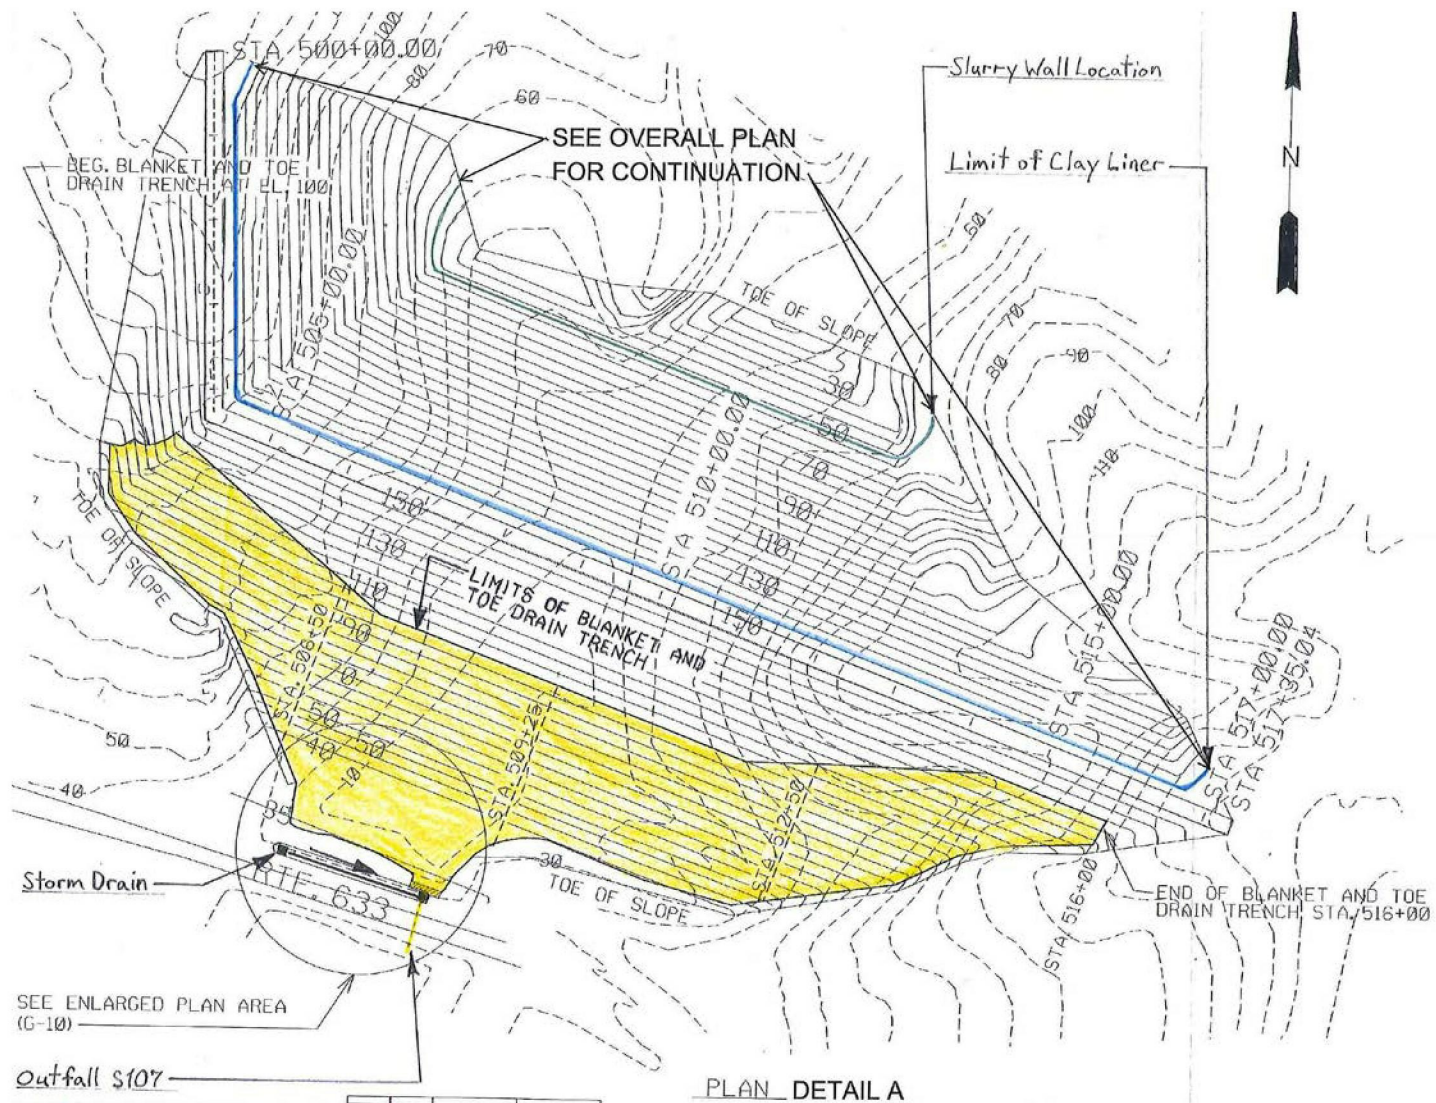
FIGURE 5
PLAN VIEW - ASH POND 'D' DAM BLANKET/TOE DRAIN LIMITS

Figure 5 is a plan view of the “new” Ash Pond D dam showing the blanket/toe drain (shaded), the surface storm drains, the previously mentioned slurry wall, and limit of the clay liner where they are located on the dam. Figure 6 is a cross section of the new Ash Pond D dam showing the blanket/toe drain, slurry wall, and clay liner limits at the approximate tallest section of the dam. Photo 5 is a 1988 construction photo showing the construction of the blanket drain. Figure 7 is a detail showing a cross section of the junction box adjacent to Possum Point Road that collects surface storm water runoff from the downstream face and adjacent areas of the Ash Pond D dam as well as inflows from the blanket/toe drain.

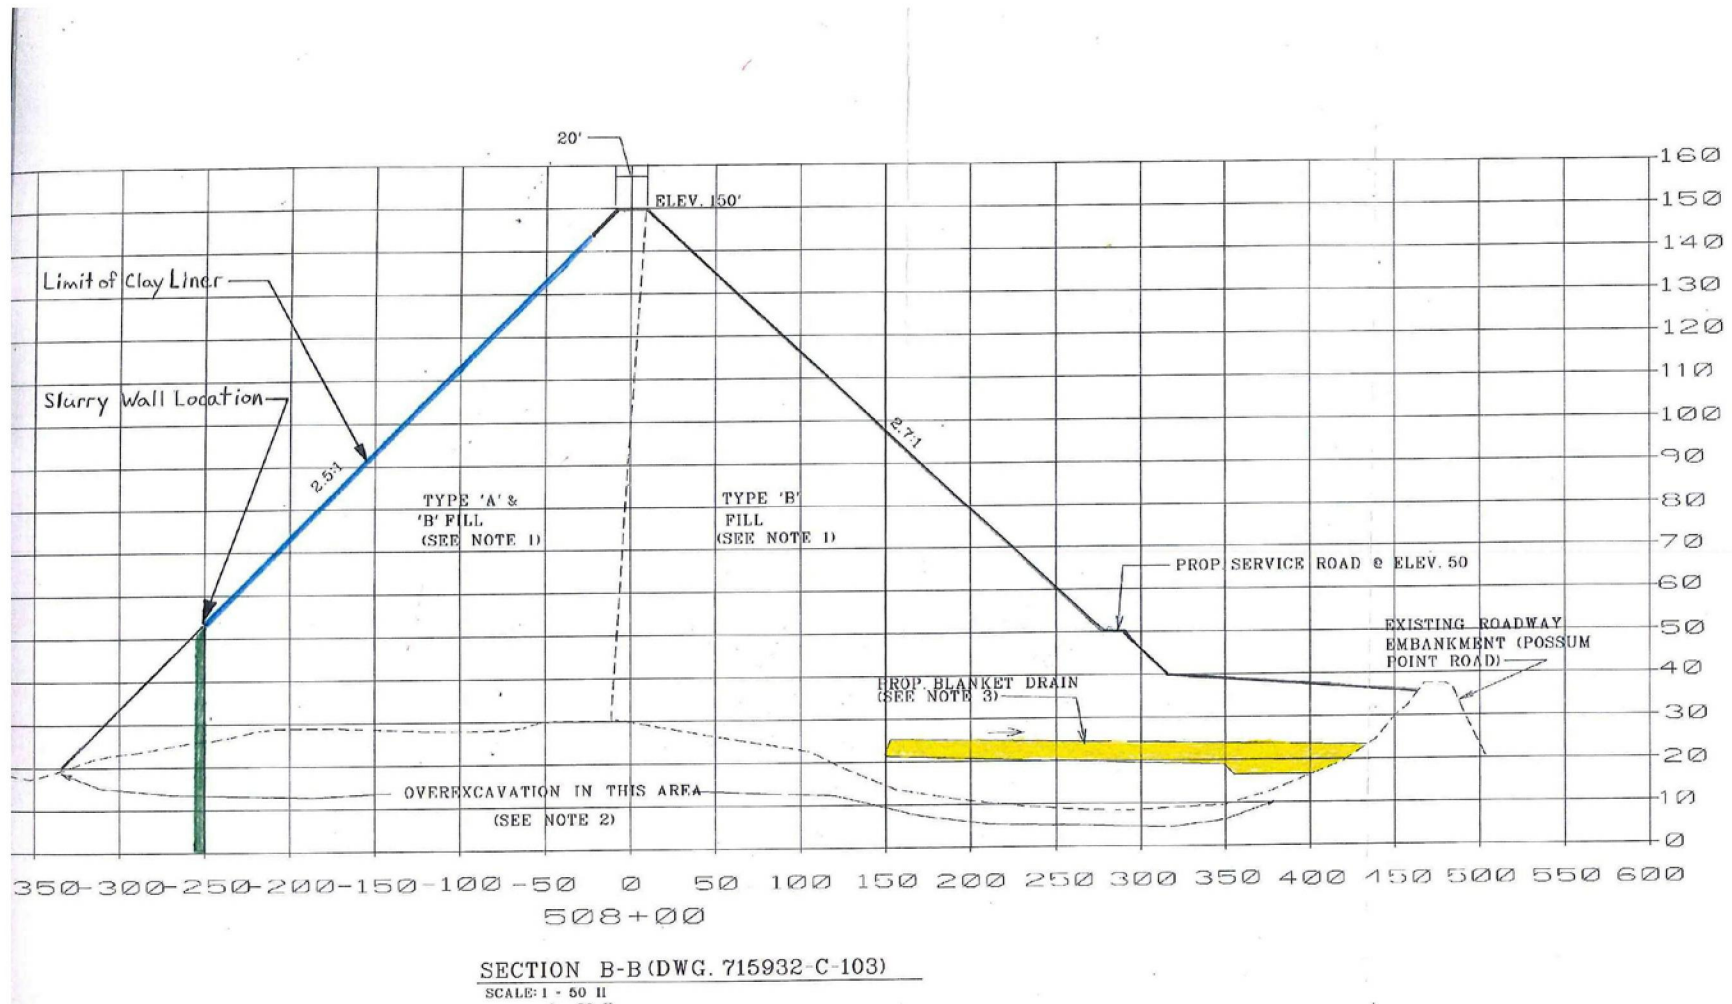
FIGURE 6
CROSS SECTION - ASH POND 'D' DAM BLANKET /TOE DRAIN
AT TALLEST SECTION

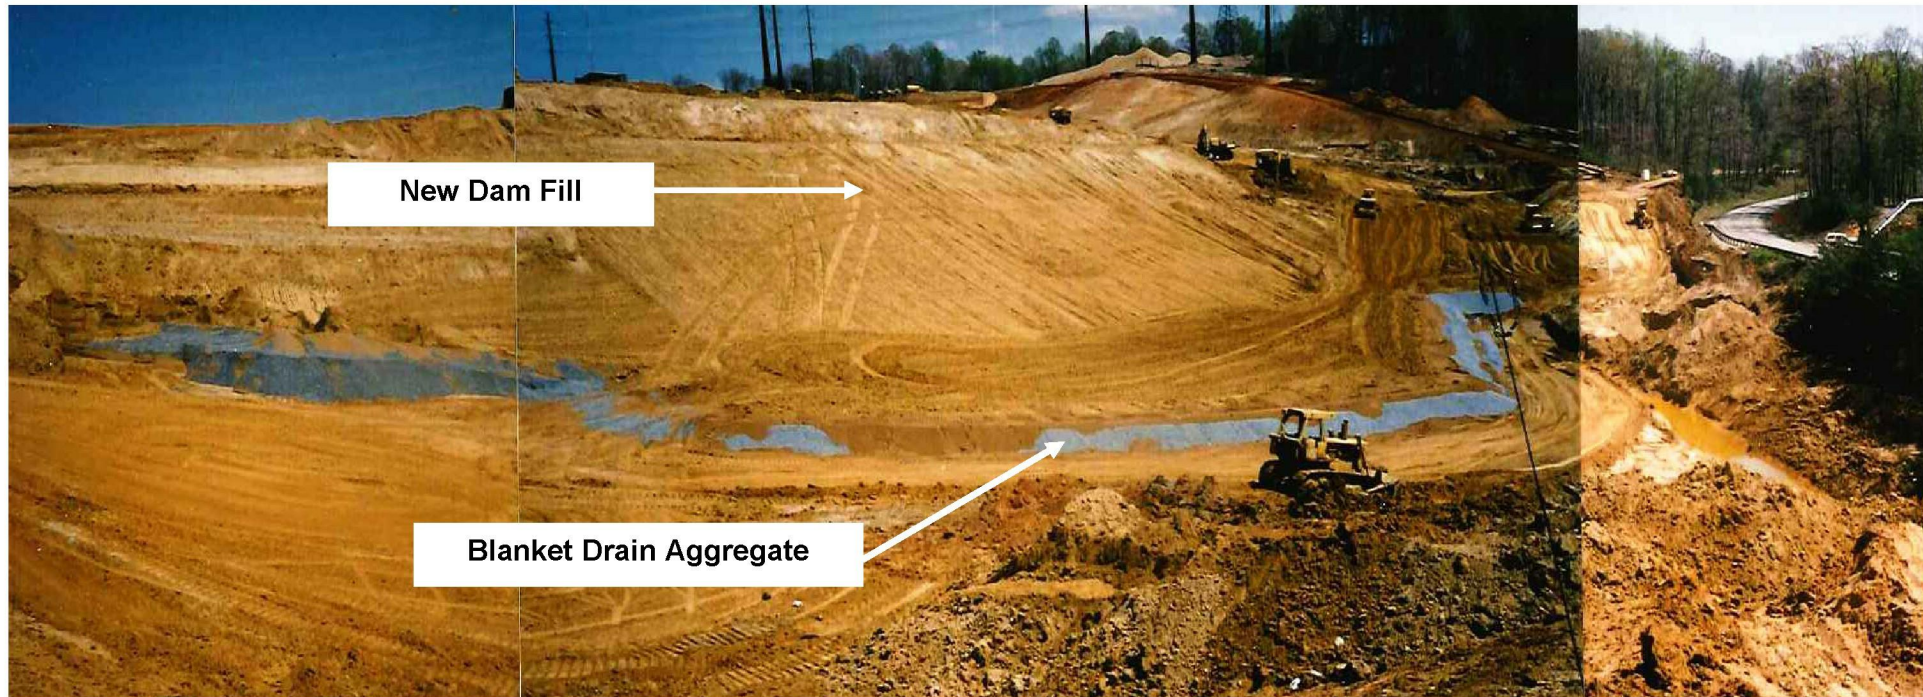
PHOTO 5
NEW ASH POND D DAM – BLANKET-TOE DRAIN CONSTRUCTION – APRIL 1988

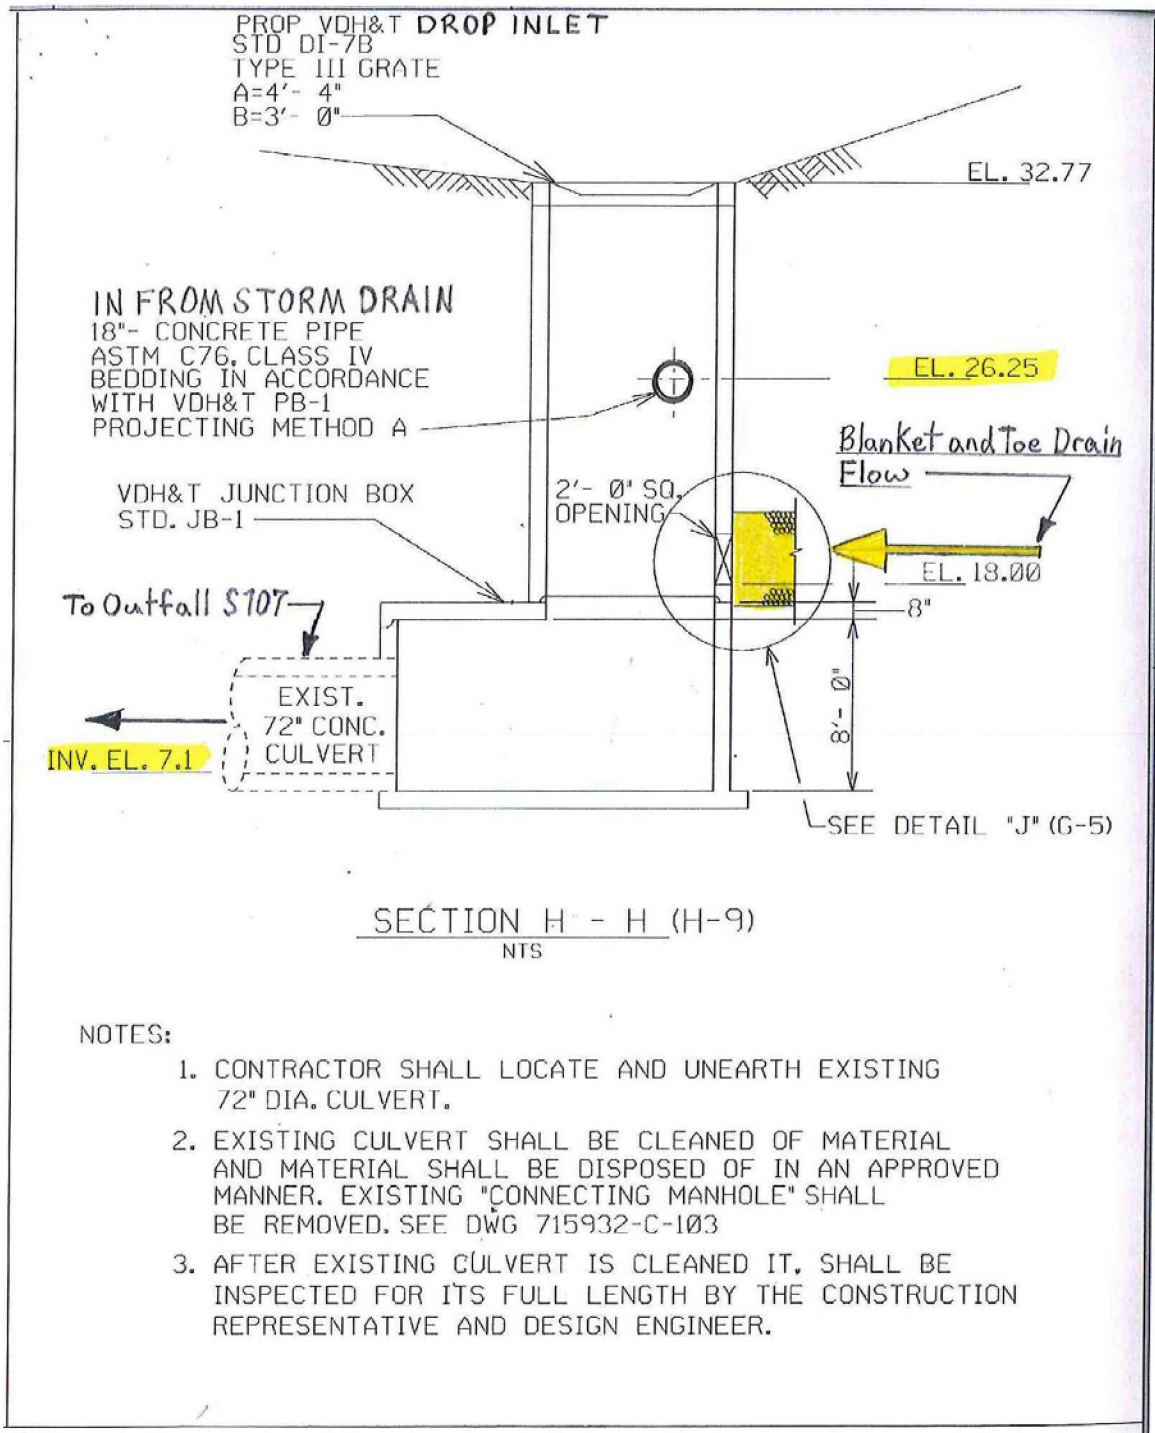
FIGURE 7
DETAIL - ASH POND 'D' DAM
BLANKET/TOE DRAIN AND STORM WATER INFLOW TO
JUNCTION BOX

This drainage system was designed to collect any infiltration through the dam or from naturally occurring groundwater and safely convey it downstream of the dam. The blanket/toe drain discharge was tied into a storm water junction box (built as part of the new dam construction) and any discharge into the box would flow through a then existing 72-inch diameter pipe that ran under Possum Point Road. The new junction box was constructed adjacent to the previously existing 72-inch pipe to provide a location for surface storm water runoff from the face of the dam and adjacent areas as well as the blanket/toe drain flow to be routed downstream.

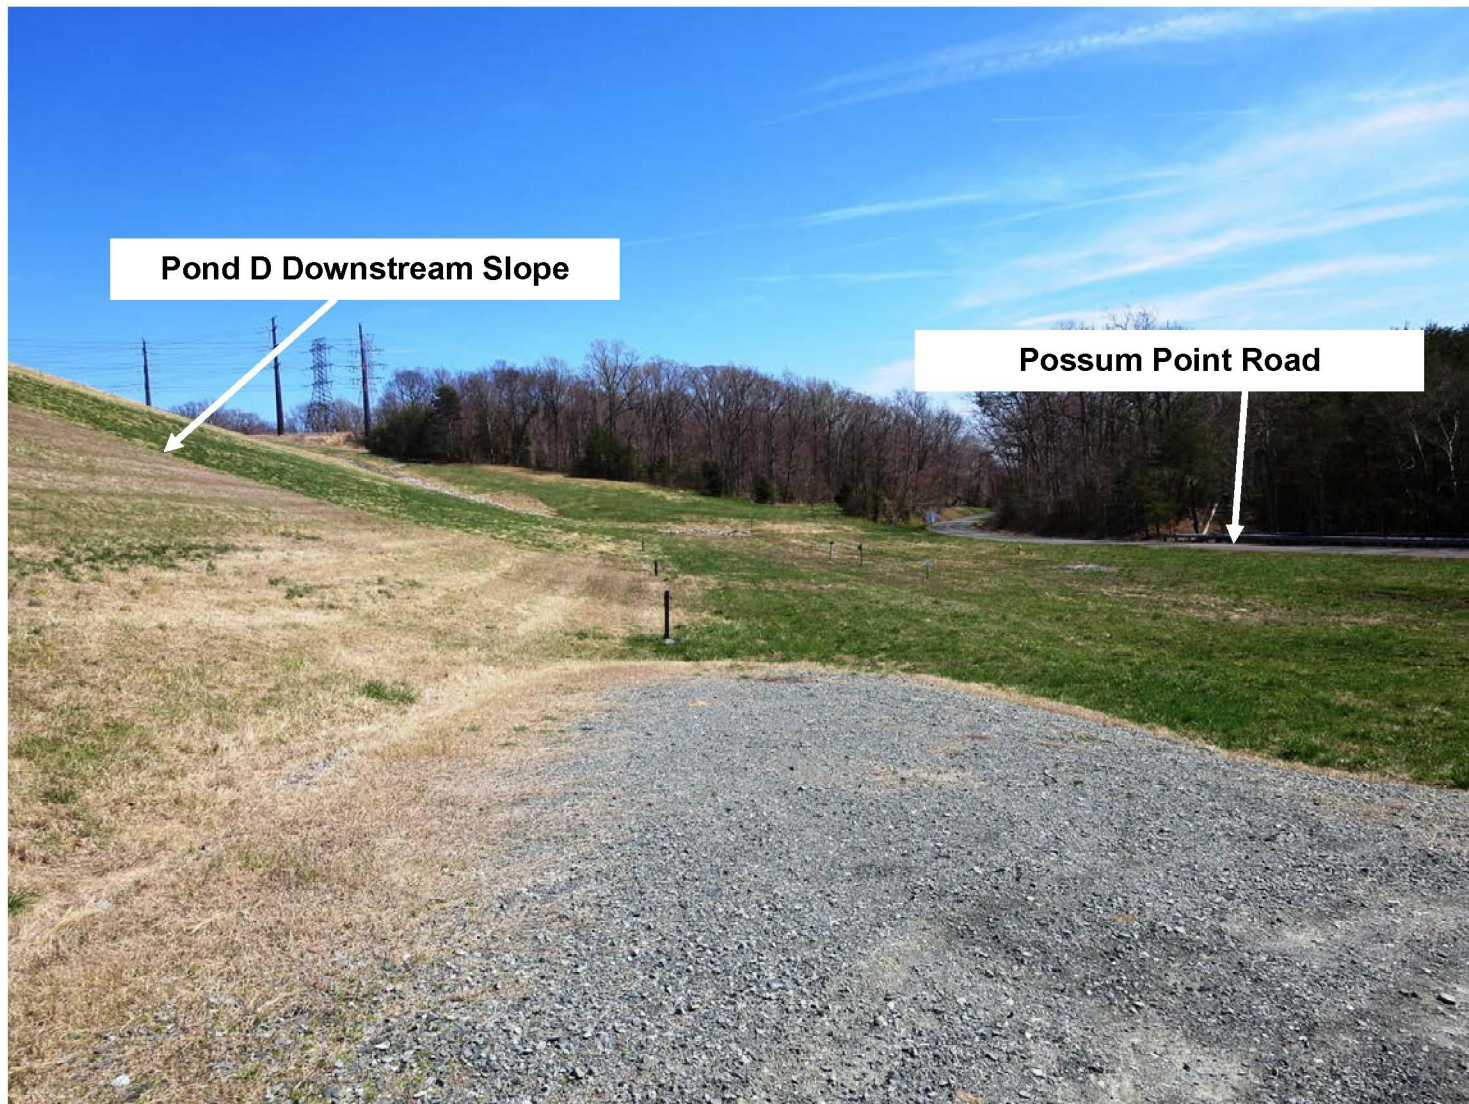
PHOTO 6
ASH POND D DOWNSTREAM SLOPE AND TOE AREA – APRIL 2014

Photo 6 is a current (2014) view of the toe area of the Ash Pond D dam and a portion of the downstream slope.
